Recreational Swimming Area Environmental Health and Safety Survey

Prospect Lake - Power To Be

Prepared by:
Katie Wilson, Victoria Community Based Water Monitoring Coordinator, Swim Drink Fish

November 2023

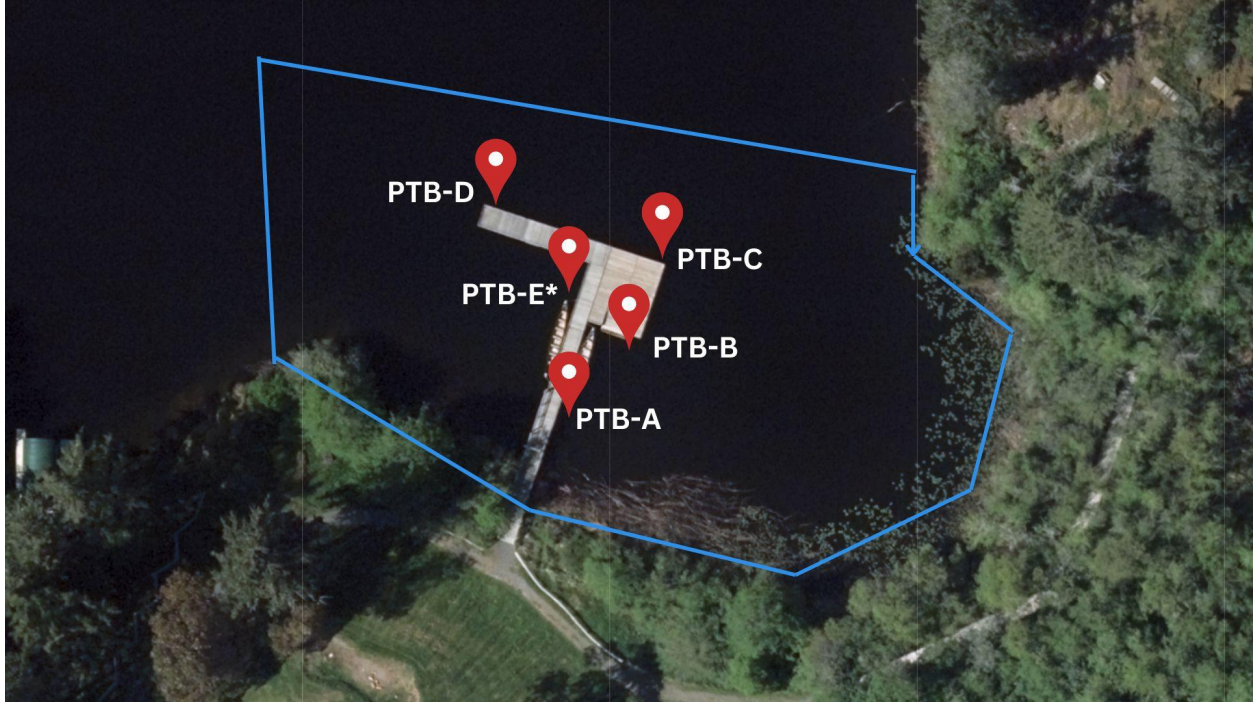
Figure 2. Power To Be water monitoring site outlined in blue with sample locations designated by red pins. * Indicates Water Rangers testing site.

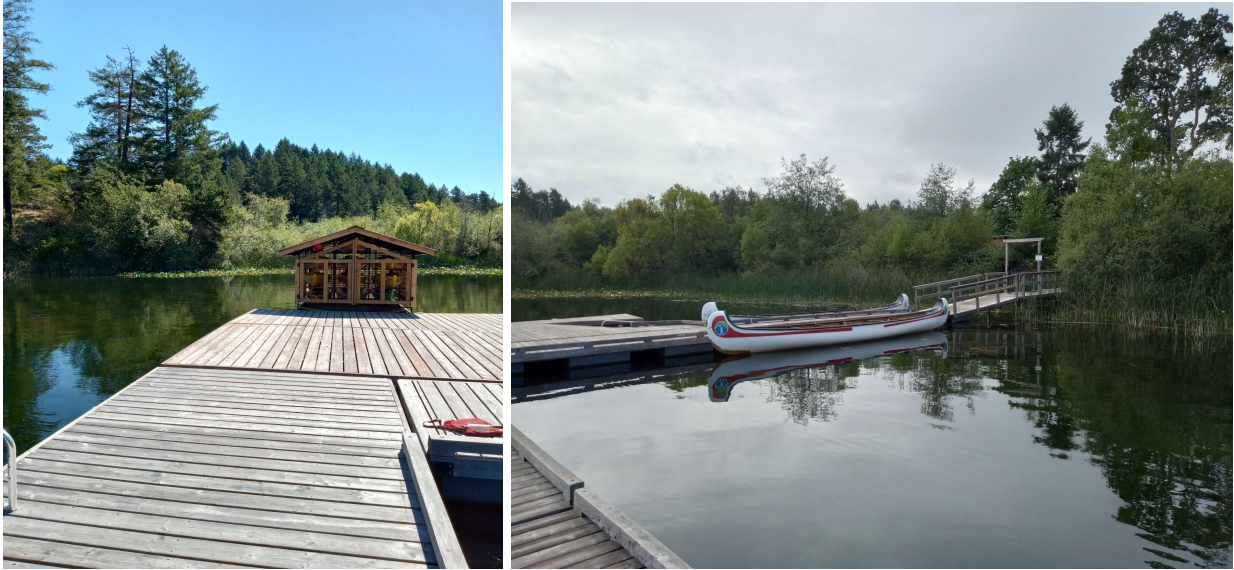
Figure 3. Standing on the west end of the dock looking east where the kayaks are stored. **Figure 4.** When glancing to the right, the dock access is visible above where two canoes are moored.

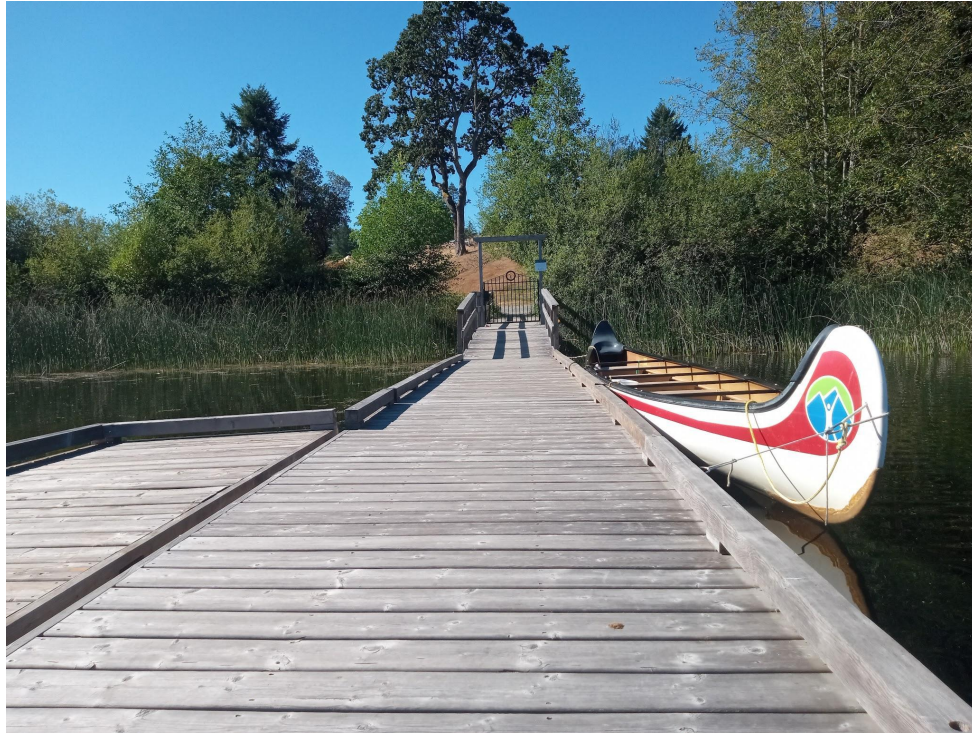
Figure 5. Looking south towards the entrance to the dock.

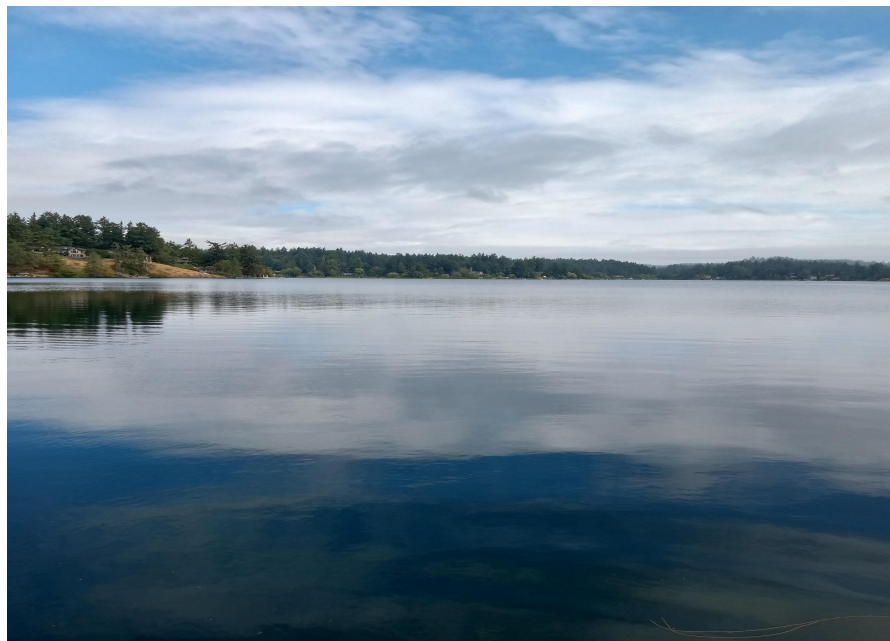
Figure 6. The view from the dock when looking northwest. Residential buildings can be seen along the perimeter of the lake.

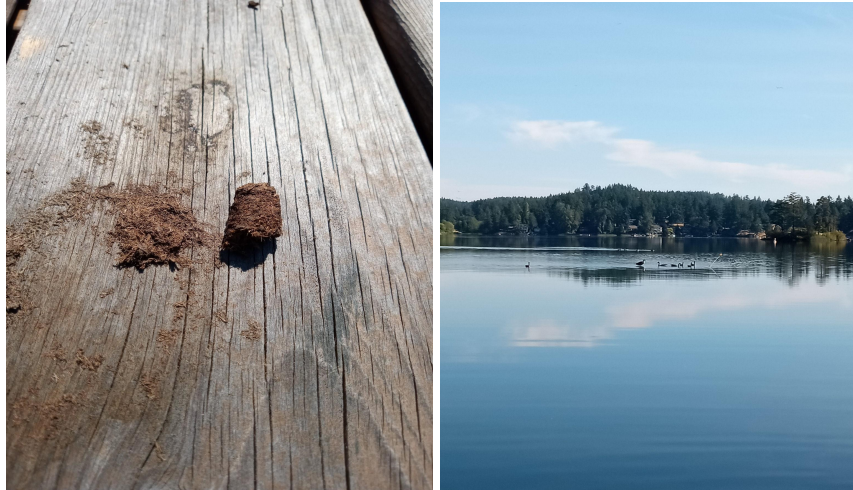
Bird species including seagulls, eagles, barn swallows, and Canada geese were spotted on and around the lake, however few were within the sampling site area. There is evidence of bird fecal waste on the dock (see Figure 8) which indicates a recurring presence. Additionally, there is a section of wetland (classified by Saanich as sensitive ecosystem inventory) located ~40m from the dock which could increase the presence of bird activity.

Figure 8. Waterfowl fecal matter is commonly found on the dock. Canada Geese are pictured both near and within the monitoring area.

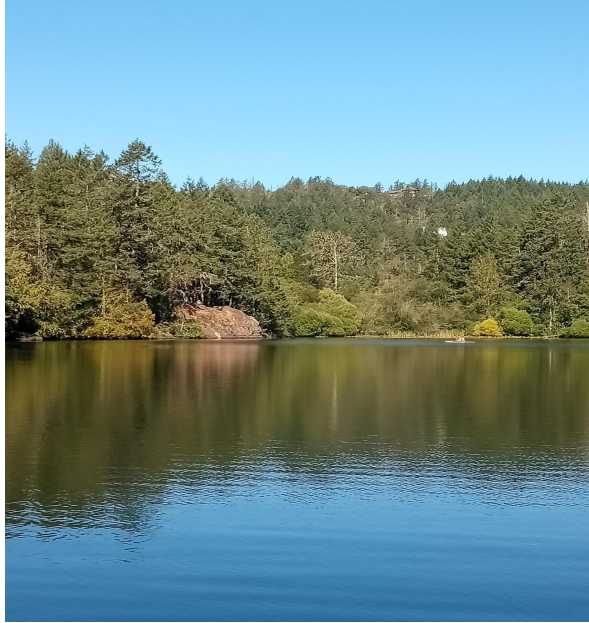
Although not publicly accessible for swimming due to safety and regulatory concerns, the Power To Be staff often swim from the dock site. Swimmers can access the lake via South Prospect Lake which is nearby the site. The risk for fecal shedding from swimmers is classified as low given the limited number of people observed swimming.

Figure 9. Paddle boarders and swimmers participating in both primary and secondary water use west of the site.

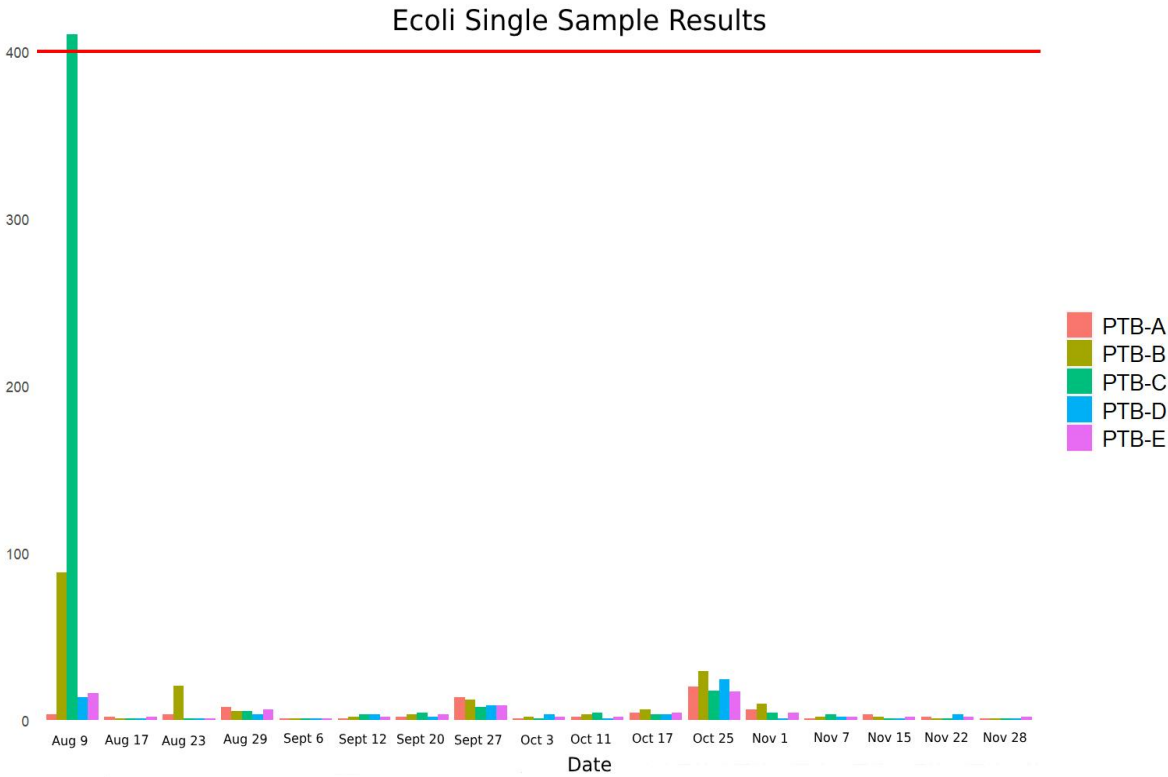
Figure 10. Graph displaying the E. coli single sample results for Power To Be for the 2023 sampling season. The y-axis represents E.coli MPN/100 mL with 400 being the single sample

maximum threshold as outlined in the Canadian Recreational Water Quality Guidelines. This was the inaugural year of monitoring at Power To Be. Power To Be was sampled 17 times between August 9, 2023 and October 11, 2023. The site met the 2019 provincial standard 100% of the time. The highest recorded geomean of the season was on August 9, 2023 with a value of 29.8 E. coli/100 ml MPN. **Disclaimer:** August 9th was the first official sample collection day at the site and based on consecutive samples, it is a high outlier. A large amount of goose fecal waste was on the dock and it is likely this resulted in higher levels of E.coli entering the water. Furthermore, it is plausible that there was a human error during sample collection.

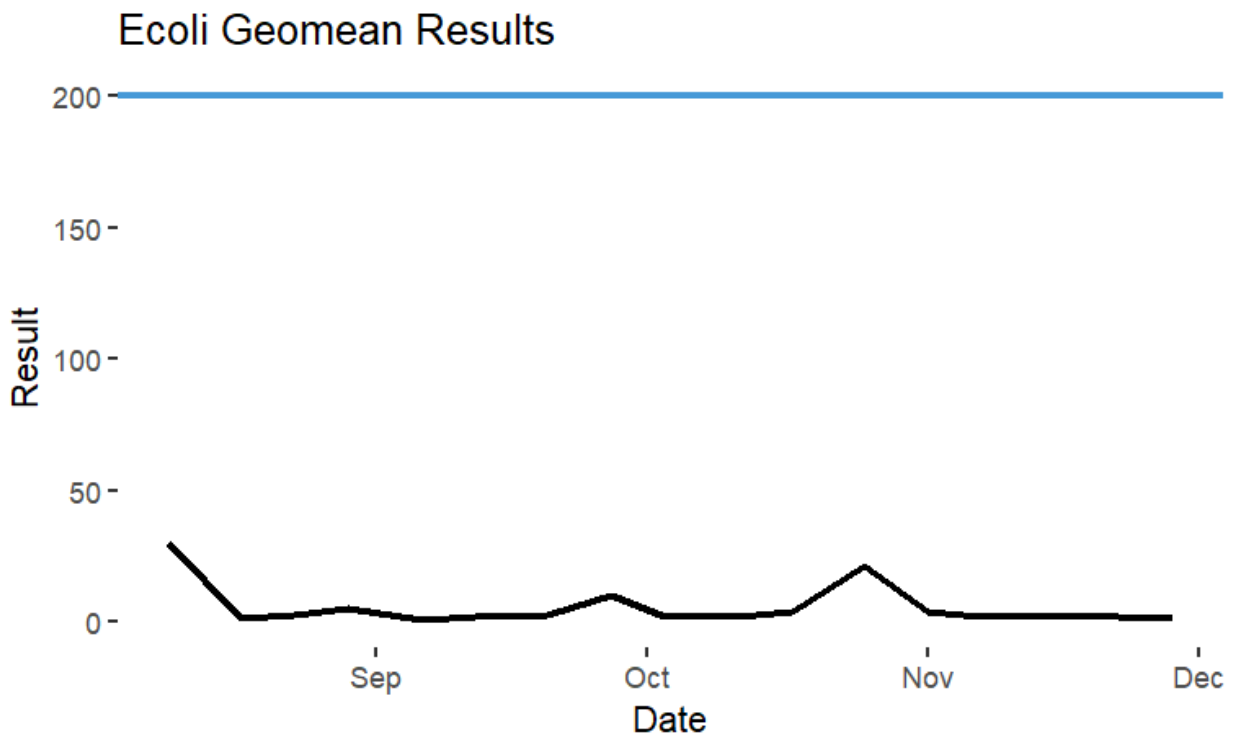
Figure 11. Graph representing the E.coli geomean results for the 2023 sampling season.

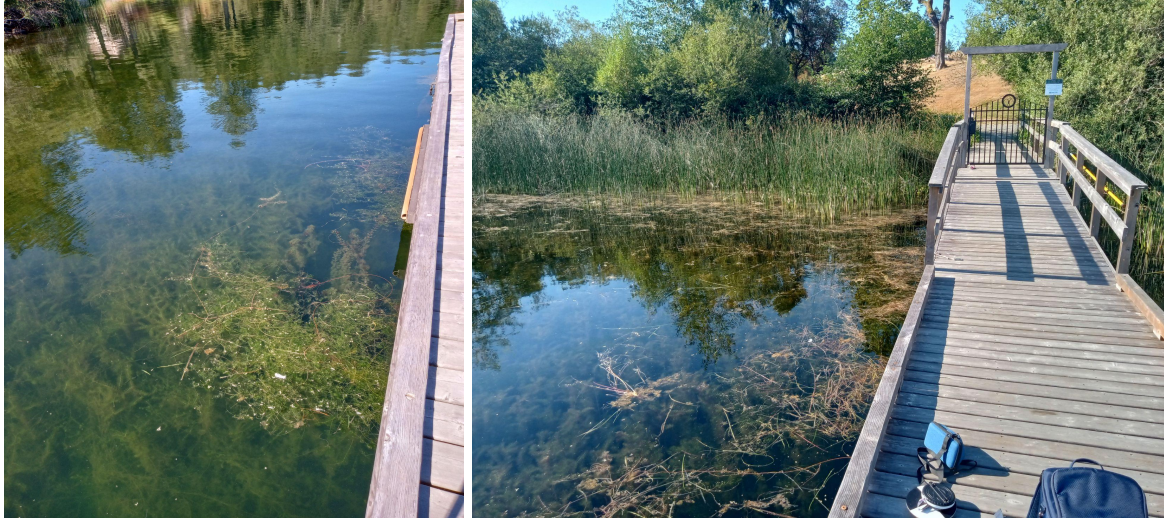
Aquatic vegetation and plants make up the majority of the lake shoreline. There is also full bottom coverage of lake weed and other plants that can be observed when standing on the dock, although the risk for injury can be considered low. The amount of growth can be spurred by sporadic levels of phosphorus which can lead to higher volumes of plant material and lower oxygen levels as a result, impacting the lake health.

Figure 12. Lakeweed is often seen floating on the water's surface.

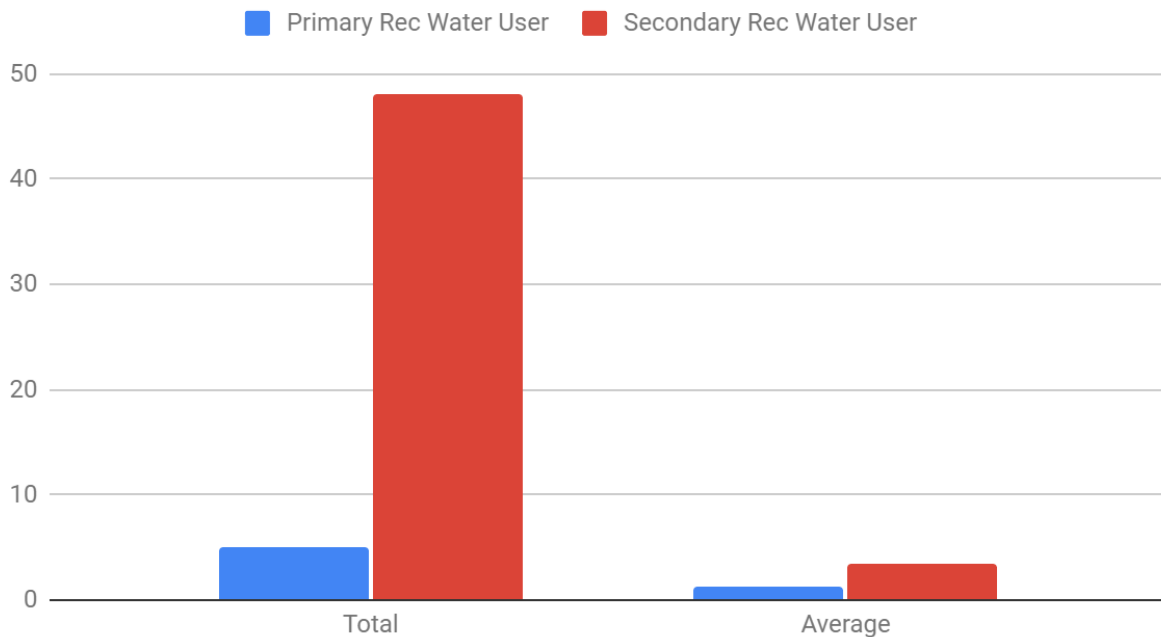
Figure 13. Graph comparing the total and average number of primary and secondary recreational water users observed over 17 days of sampling.

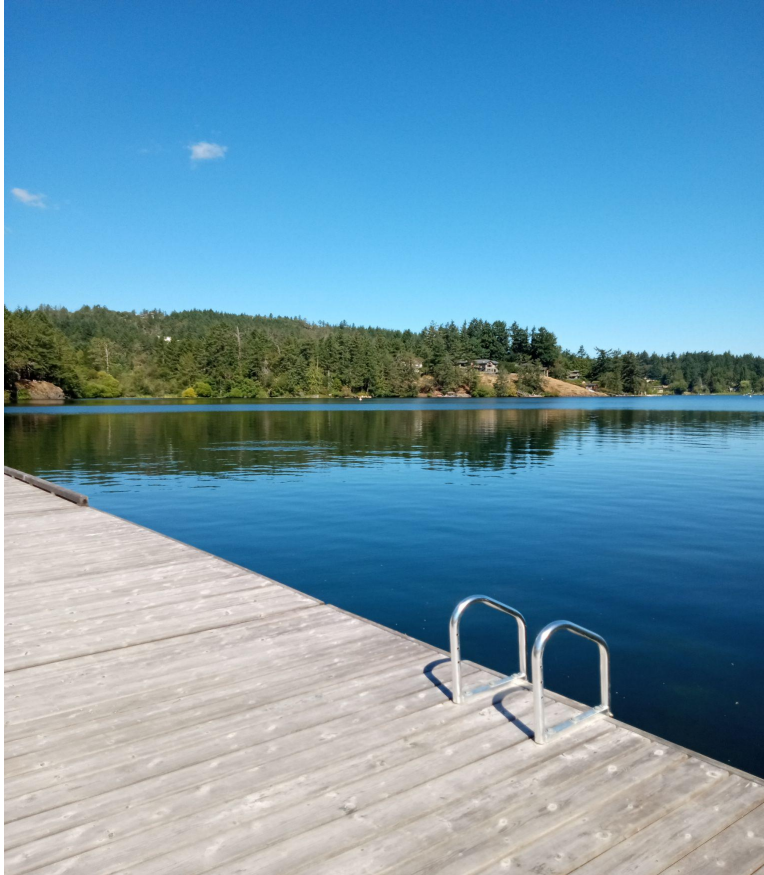
At the end of the dock to the left, the depth is >4.5 m. The bottom material is likely sandy substrate, lake weed, and debris. Participants of Power To Be's programs require the use of a PFD while near or on the water, minimizing safety risks.

Figure 14. There is a swim ladder providing a safe method to exit the water should there be an accident or hazard.
